*DoD Corrosion Prevention and Control Program*

## **Implementation of Remote Corrosion- Monitoring Sensor for Mission-Essential Structures at Okinawa**

Final Report on Project FAR-04 for FY06

August 2009

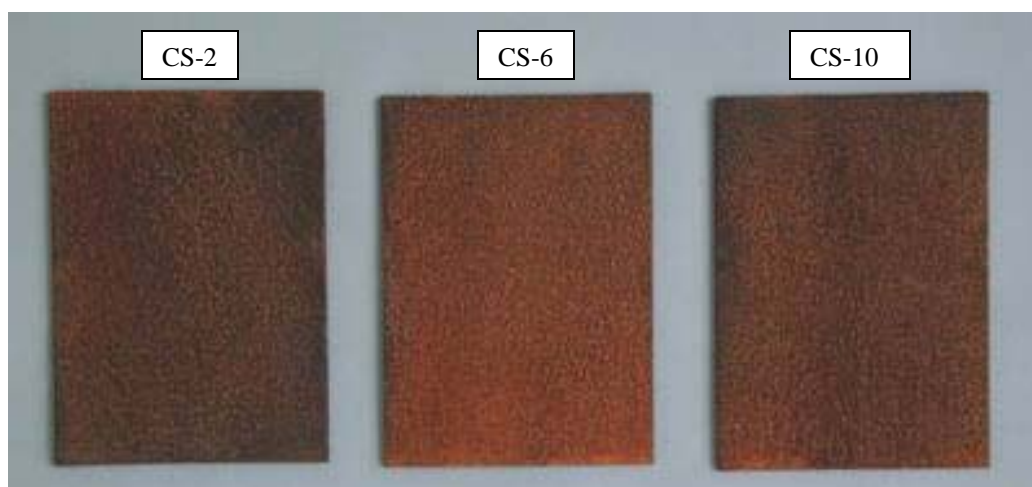
Figure 9a – Carbon steel, 2nd removal (144 days); ~500-ft, front face

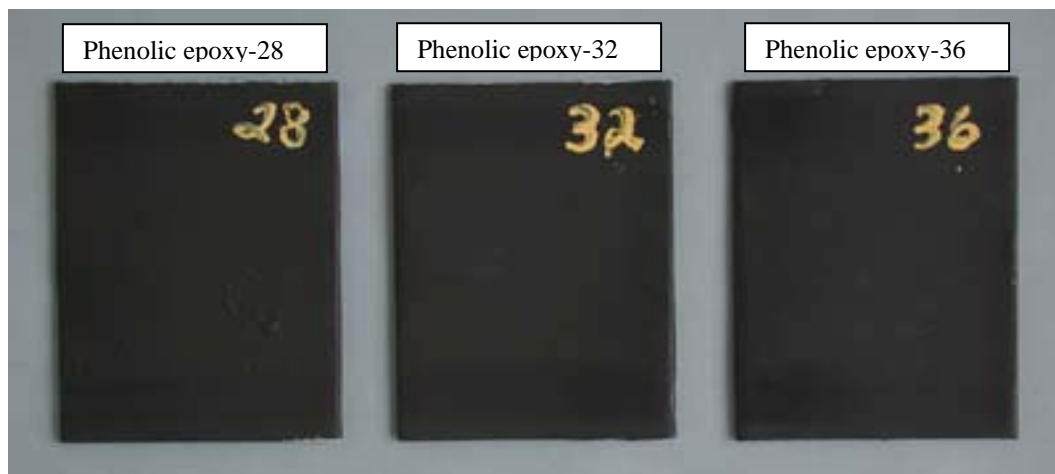
Figure 12b – Phenolic epoxy coated steel, 2nd removal (144 days); ~500-ft, backside; the “bubbles” in the coating on panel #28 are drips from the original application and not blisters due to coating deterioration

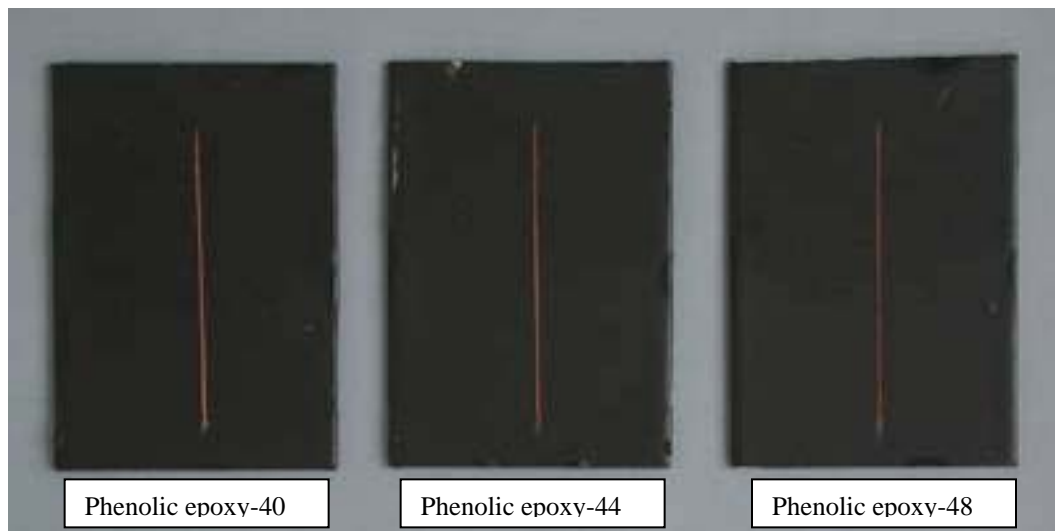
Figure 12c – Phenolic epoxy coated steel, 2nd removal (143 days); ~2000-ft, front face

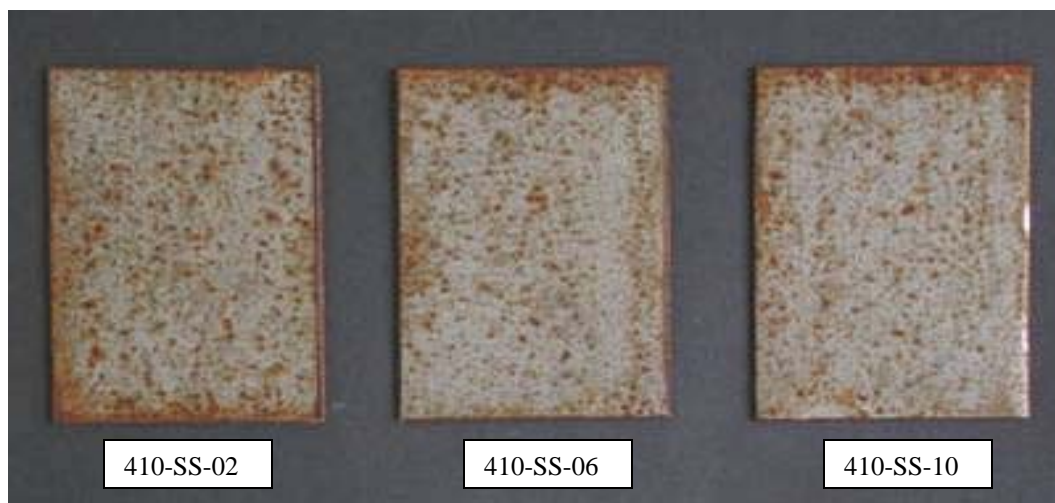
Figure 13a – 410 Stainless steel, 2nd removal (144 days); ~500-ft, front face

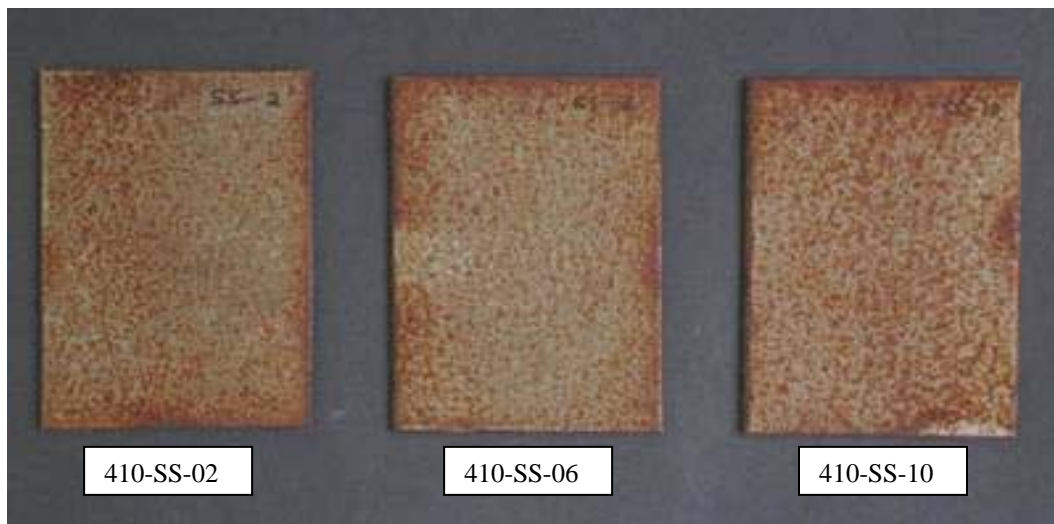
Figure 13b – 410 Stainless steel, 2nd removal (144 days); ~500-ft, backside

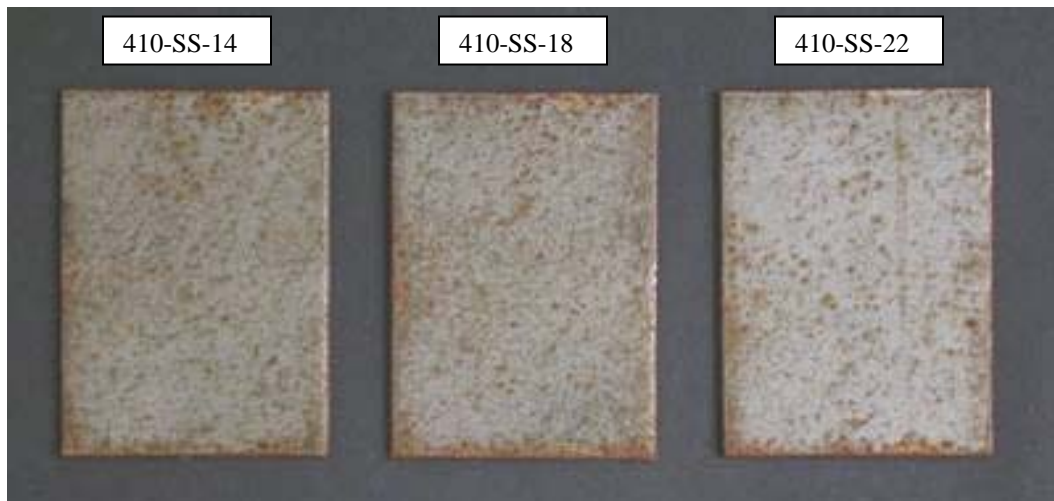
Figure 13c – 410 Stainless steel, 2nd removal (143 days); ~2000-ft, front face

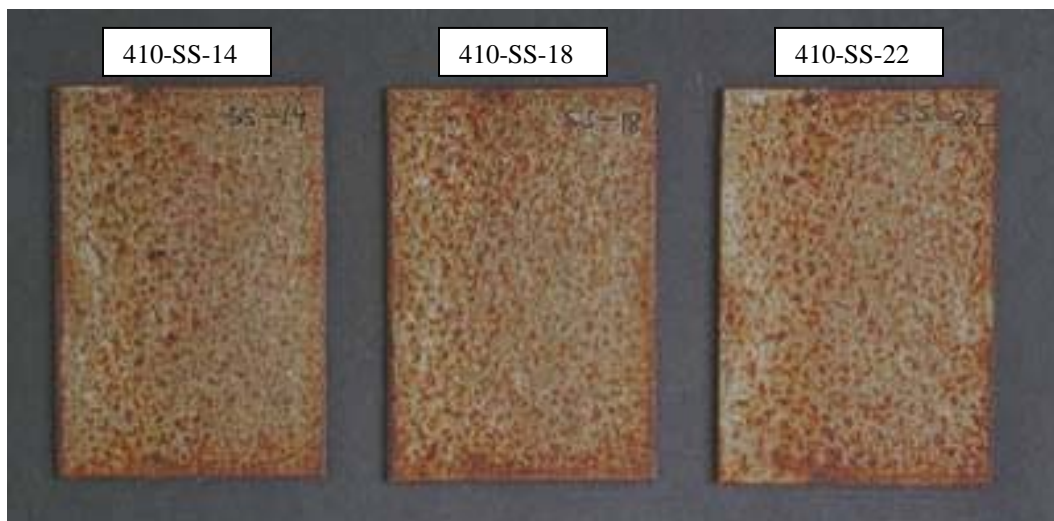
Figure 13d – 410 Stainless steel, 2nd removal (143 days); ~2000-ft, backside

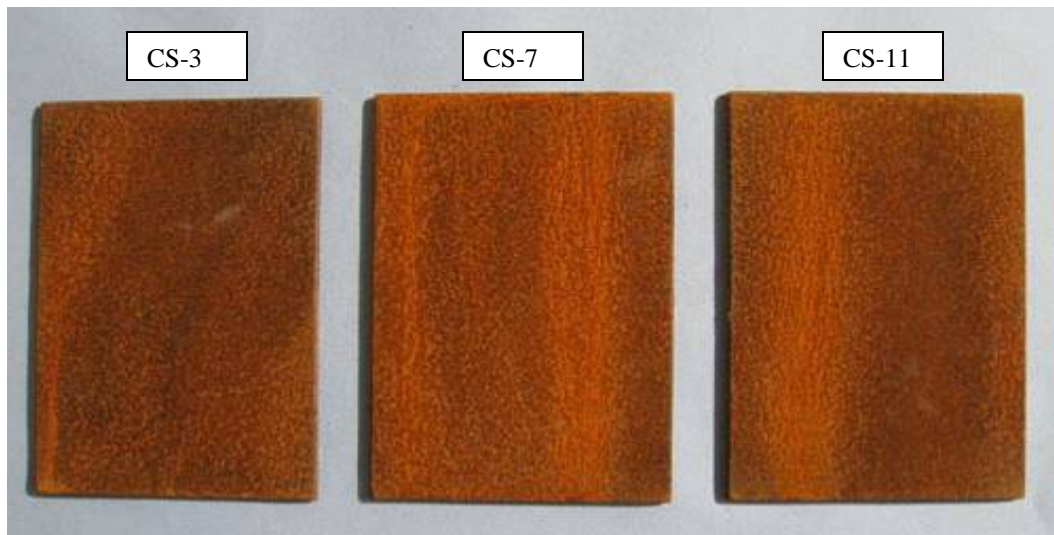
Figure 14a – Carbon steel, 3rd removal (213 days); ~500-ft, front face

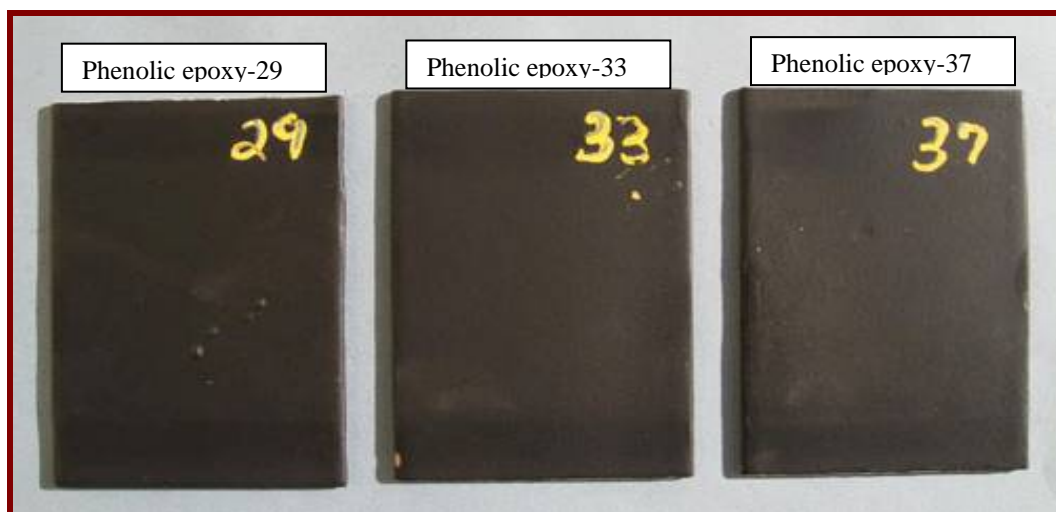
Figure 17b – Phenolic epoxy coated steel, 3rd removal (213 days); ~500-ft, backside. The “bubbles” in the coating on panel #29 are drips from the original application and not blisters due to coating deterioration.

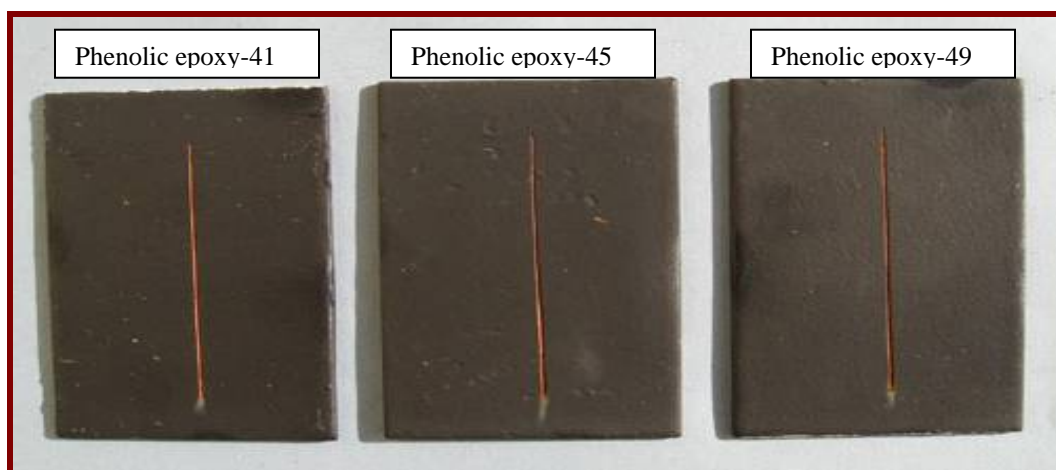
Figure 17c – Phenolic epoxy coated steel, 3rd removal (212 days); ~2000-ft, front face; indentations on the coated panels were present before exposure

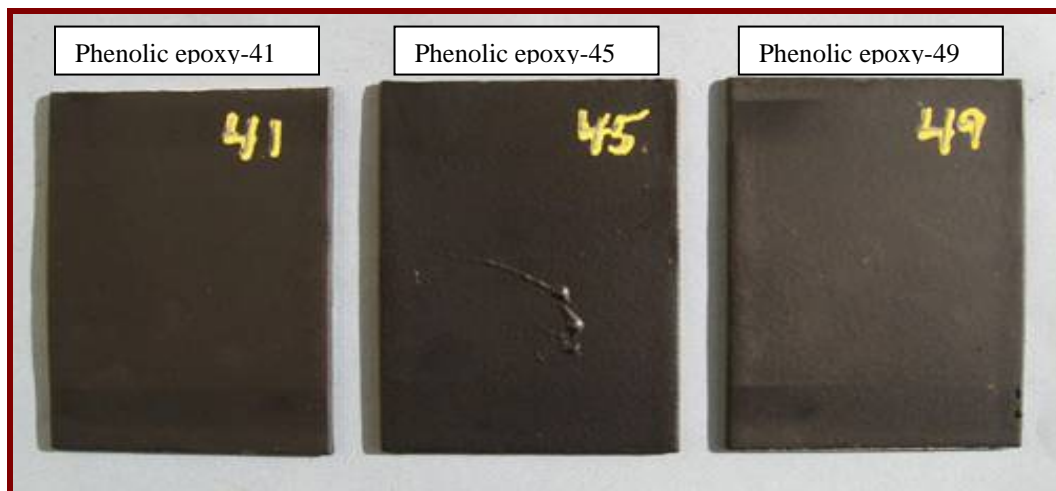
Figure 17d – Phenolic epoxy coated steel, 3rd removal (212 days); ~2000-ft, backside. The “bubbles” in the coating on panel #45 are drips from the original application and not blisters due to coating deterioration

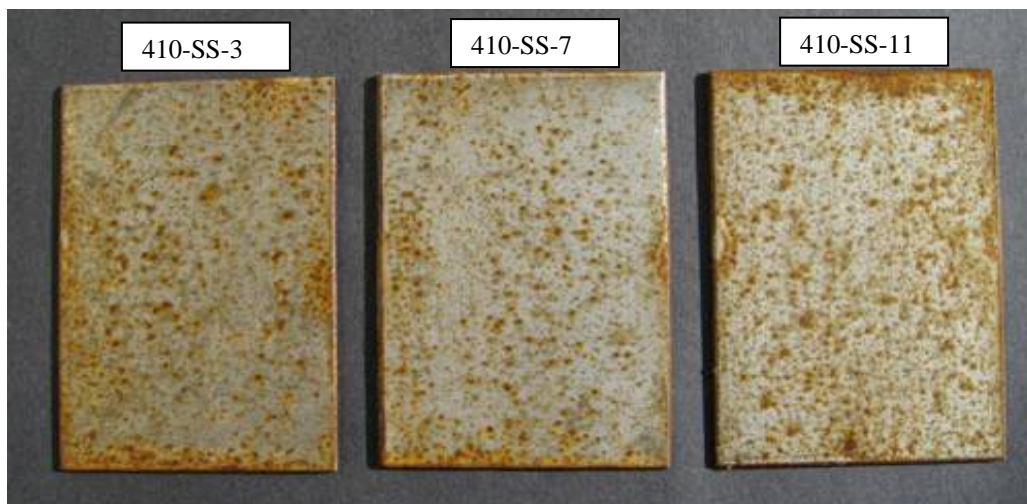
Figure 18a – 410 Stainless steel, 3rd removal (213 days); ~500-ft, front face

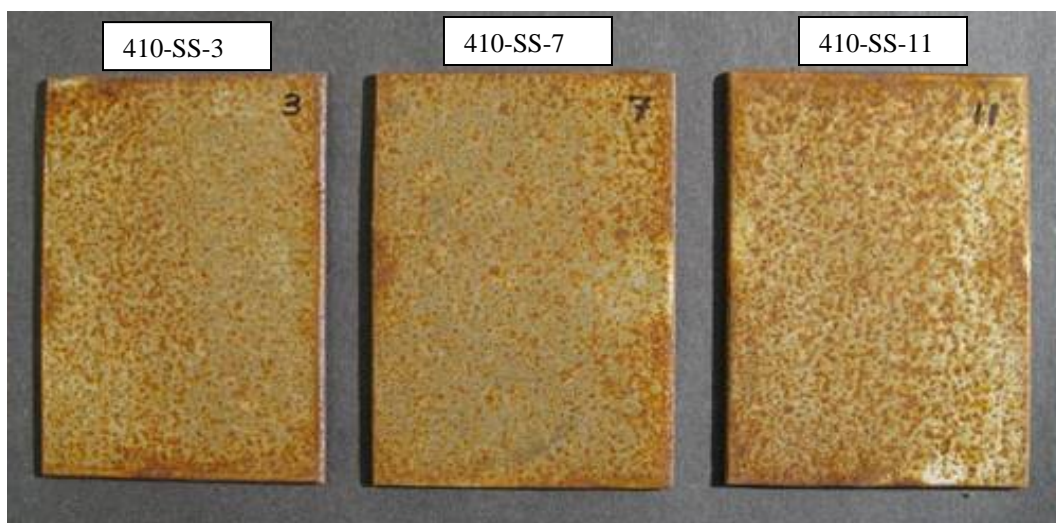
Figure 18b – 410 Stainless steel, 3rd removal (213 days); ~500-ft, backside

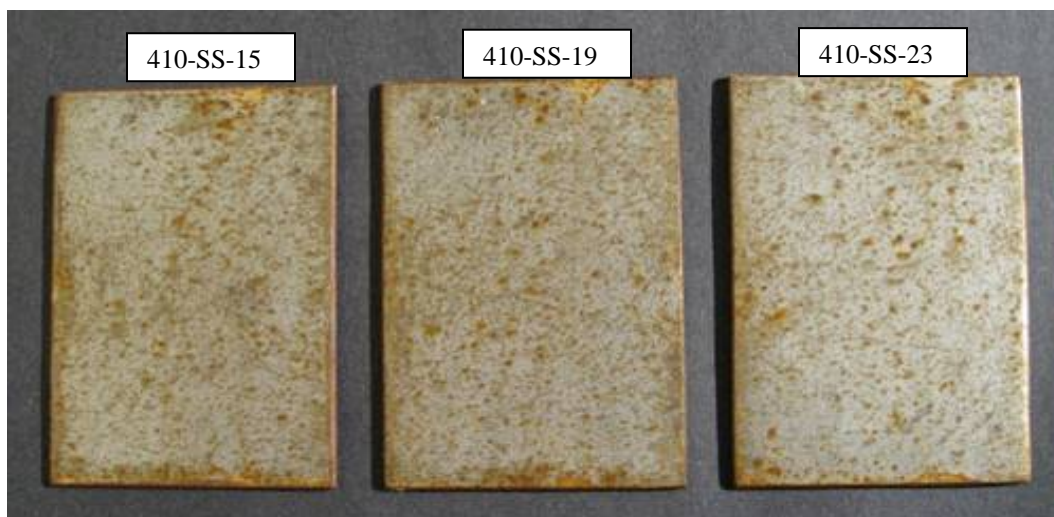
Figure 18c – 410 Stainless steel, 3rd removal (212 days); ~2000-ft, front face

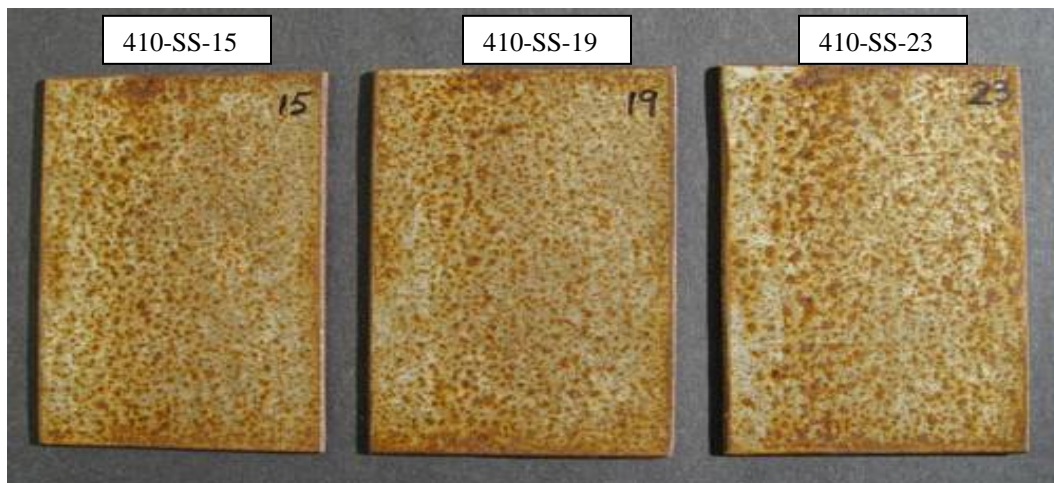
Figure 18d – 410 Stainless steel, 3rd removal (212 days); ~2000-ft, backside

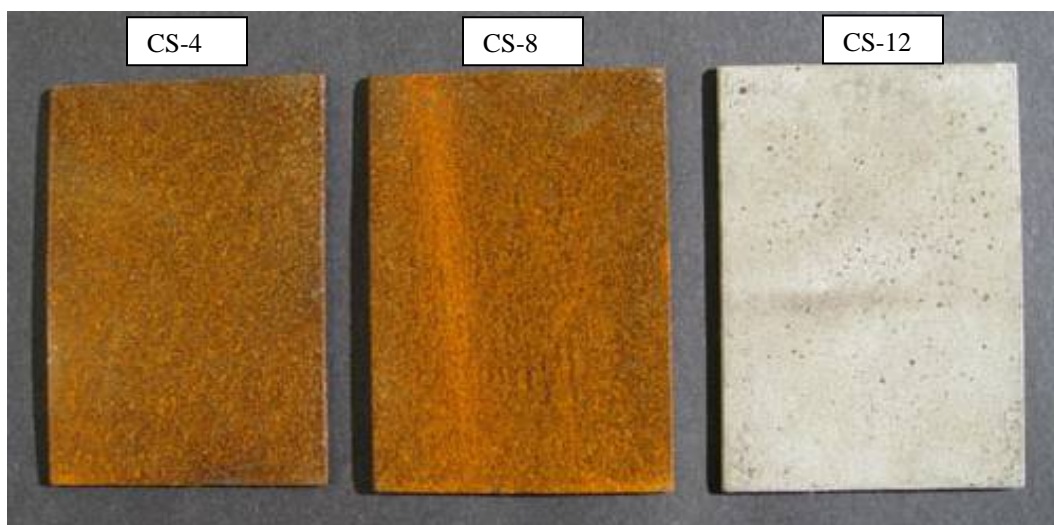
Figure 19a – Carbon steel, 4th removal (247 days); ~500-ft, front face  
(Panel CS-12 – After cleaning)

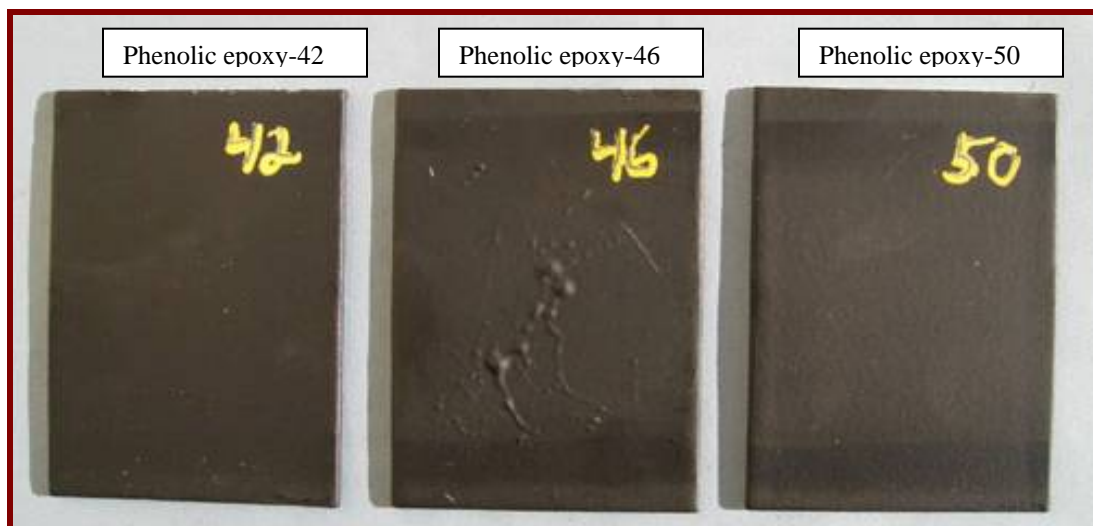
Figure 22d – Phenolic-epoxy coated steel, 4th removal (246 days); ~2000-ft, backside.

The “bubbles” in the coating on panel #46 are drips from the original application and not blisters due to coating deterioration.

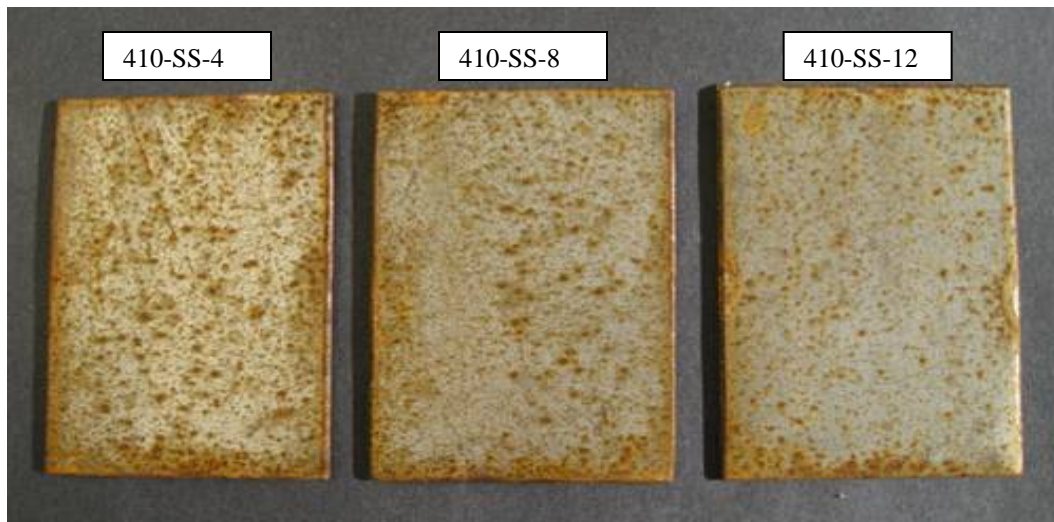
Figure 23a – 410 Stainless steel, 4th removal (247 days); ~500-ft, front face

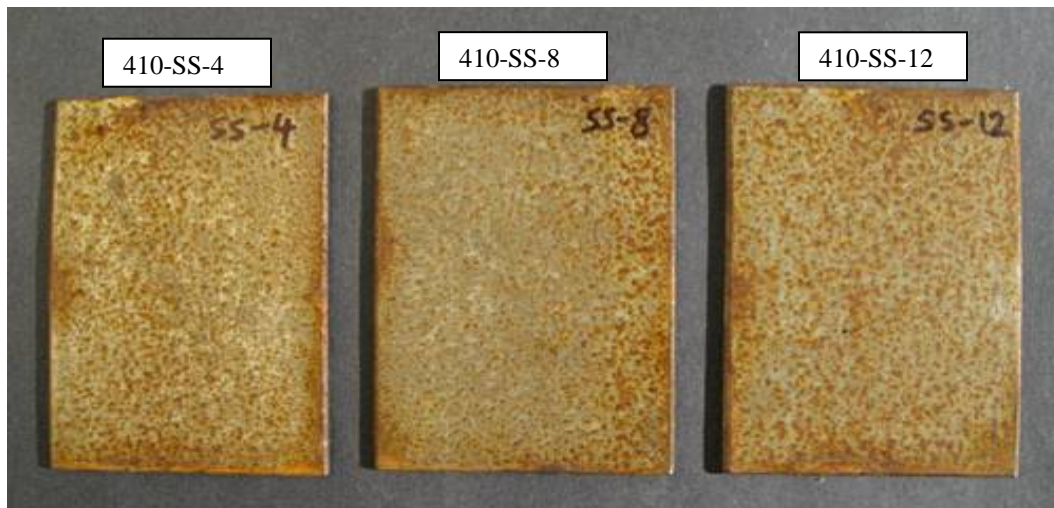
Figure 23b – 410 Stainless steel, 4th removal (247 days); ~500-ft, backside

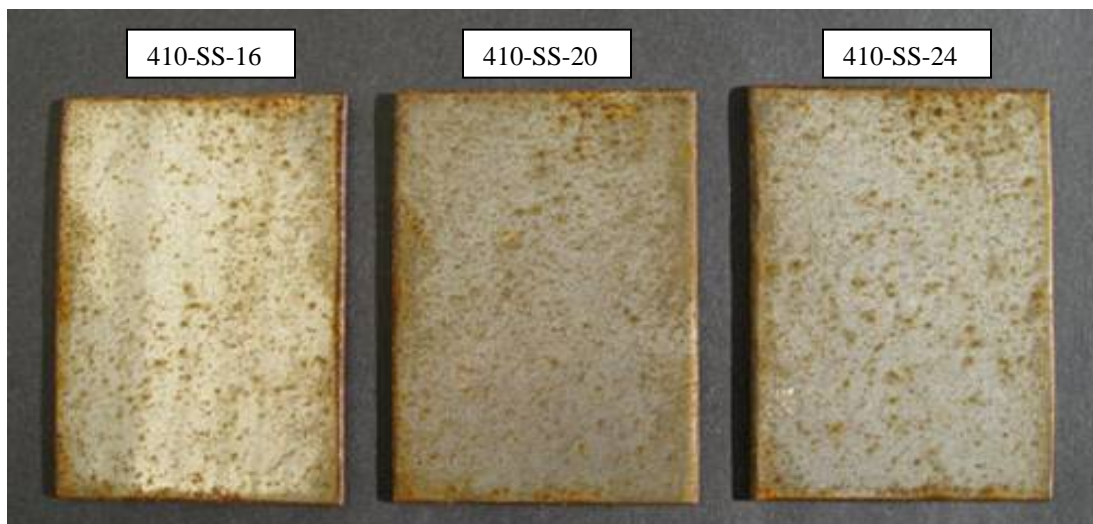
Figure 23c – 410 Stainless steel, 4th removal (246 days); ~2000-ft, front face

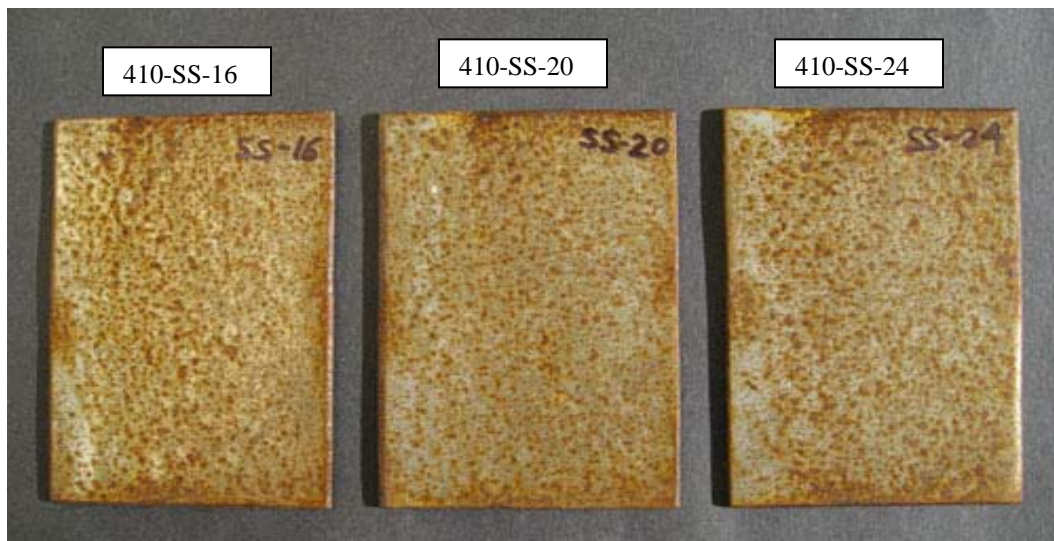
Figure 23d – 410 Stainless steel, 4th removal (246 days); ~2000-ft, backside

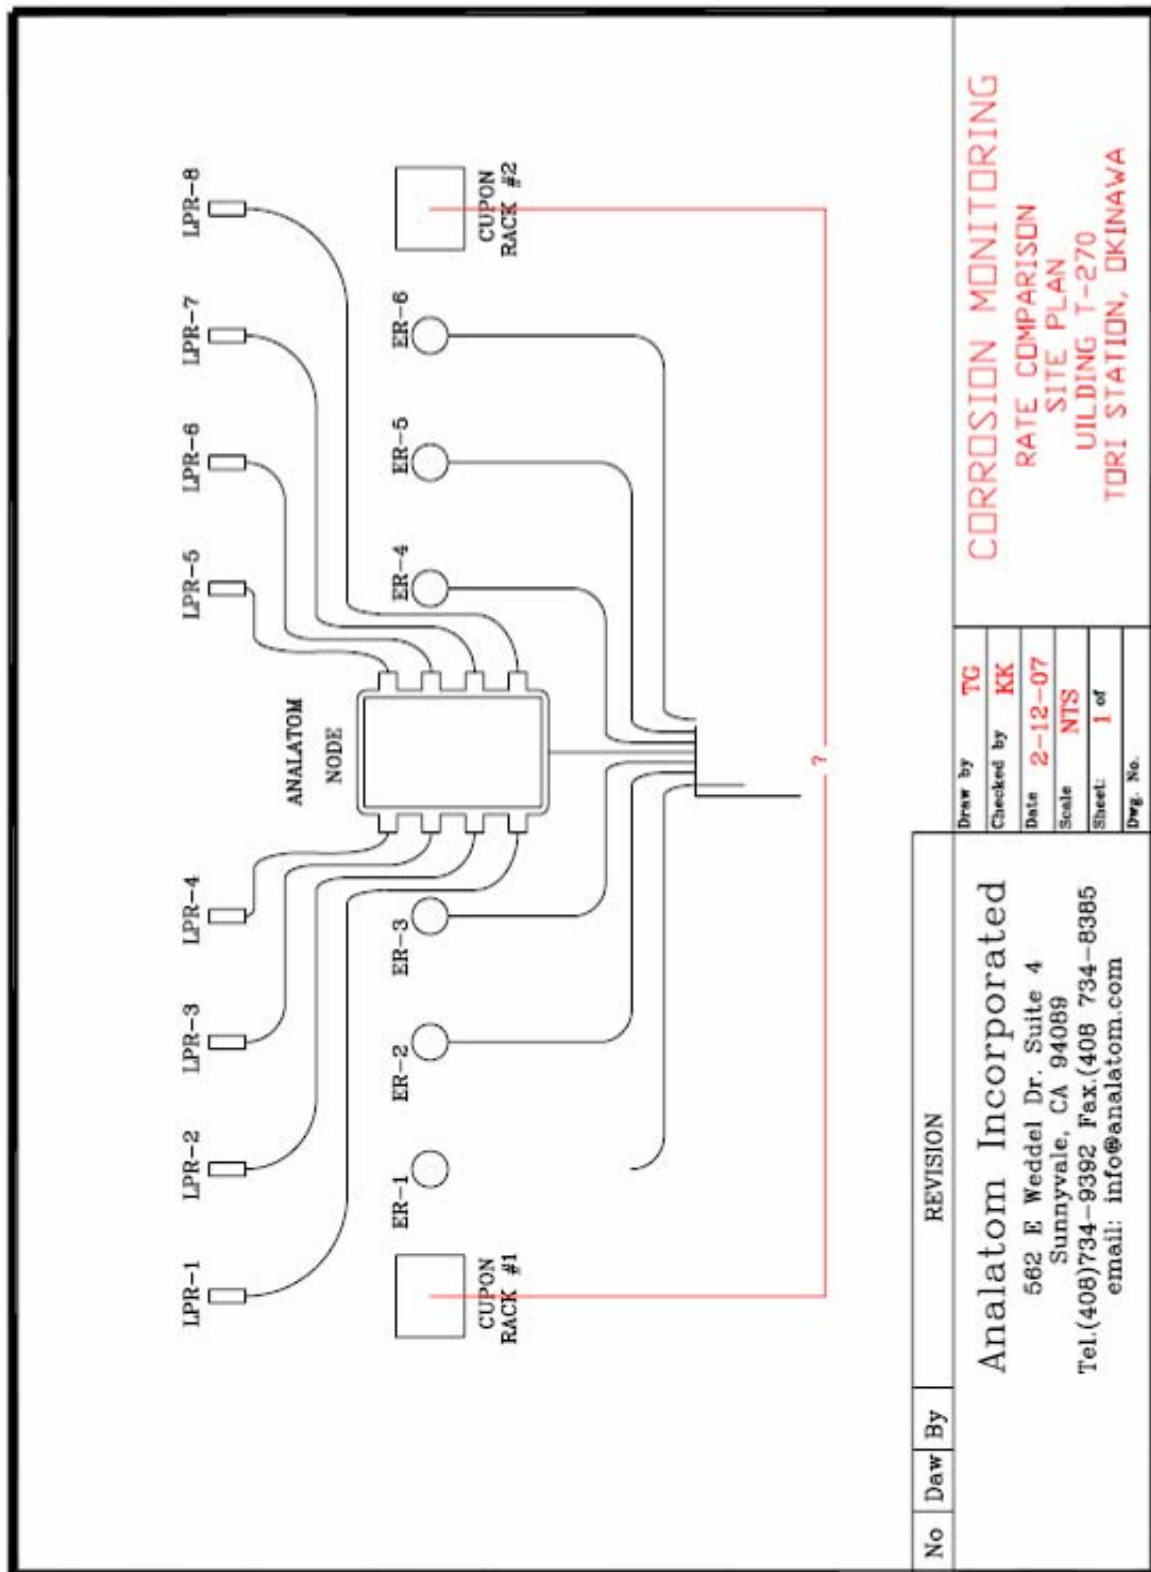
Figure 3. LPR corrosion sensor layout for roof installation.

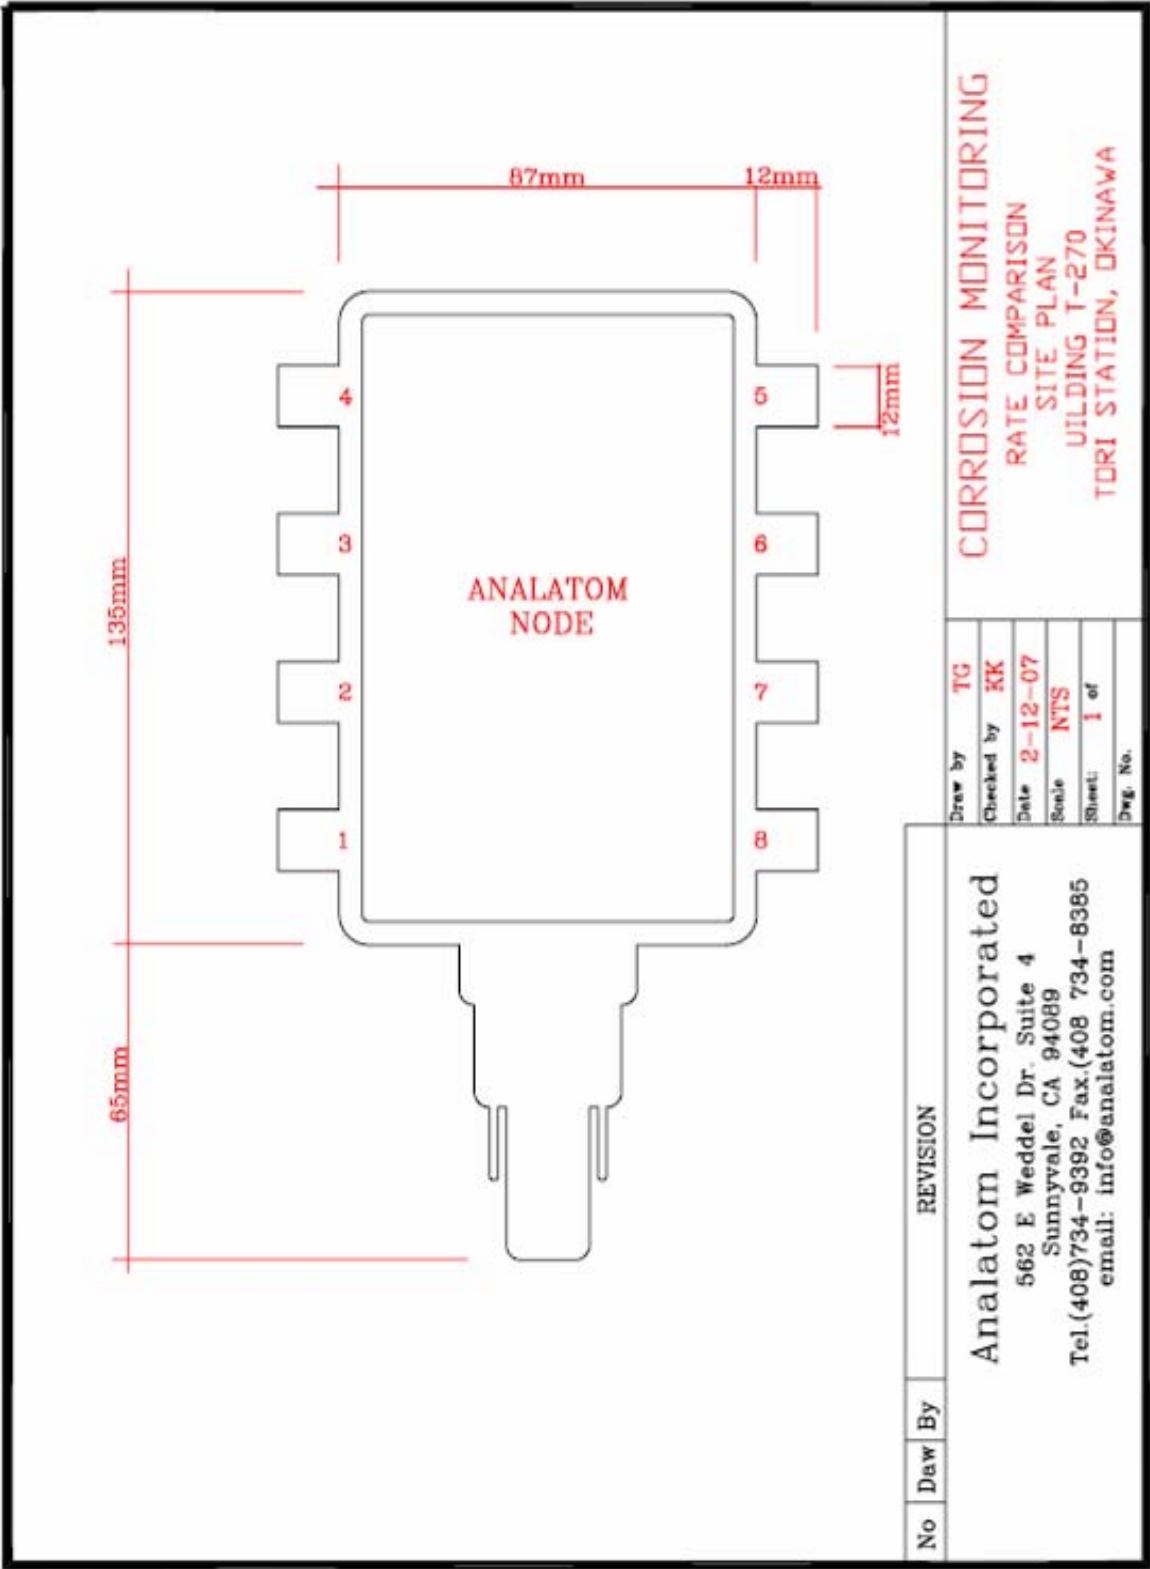
Figure 4: Analatom LPR corrosion sensor system node schematic.

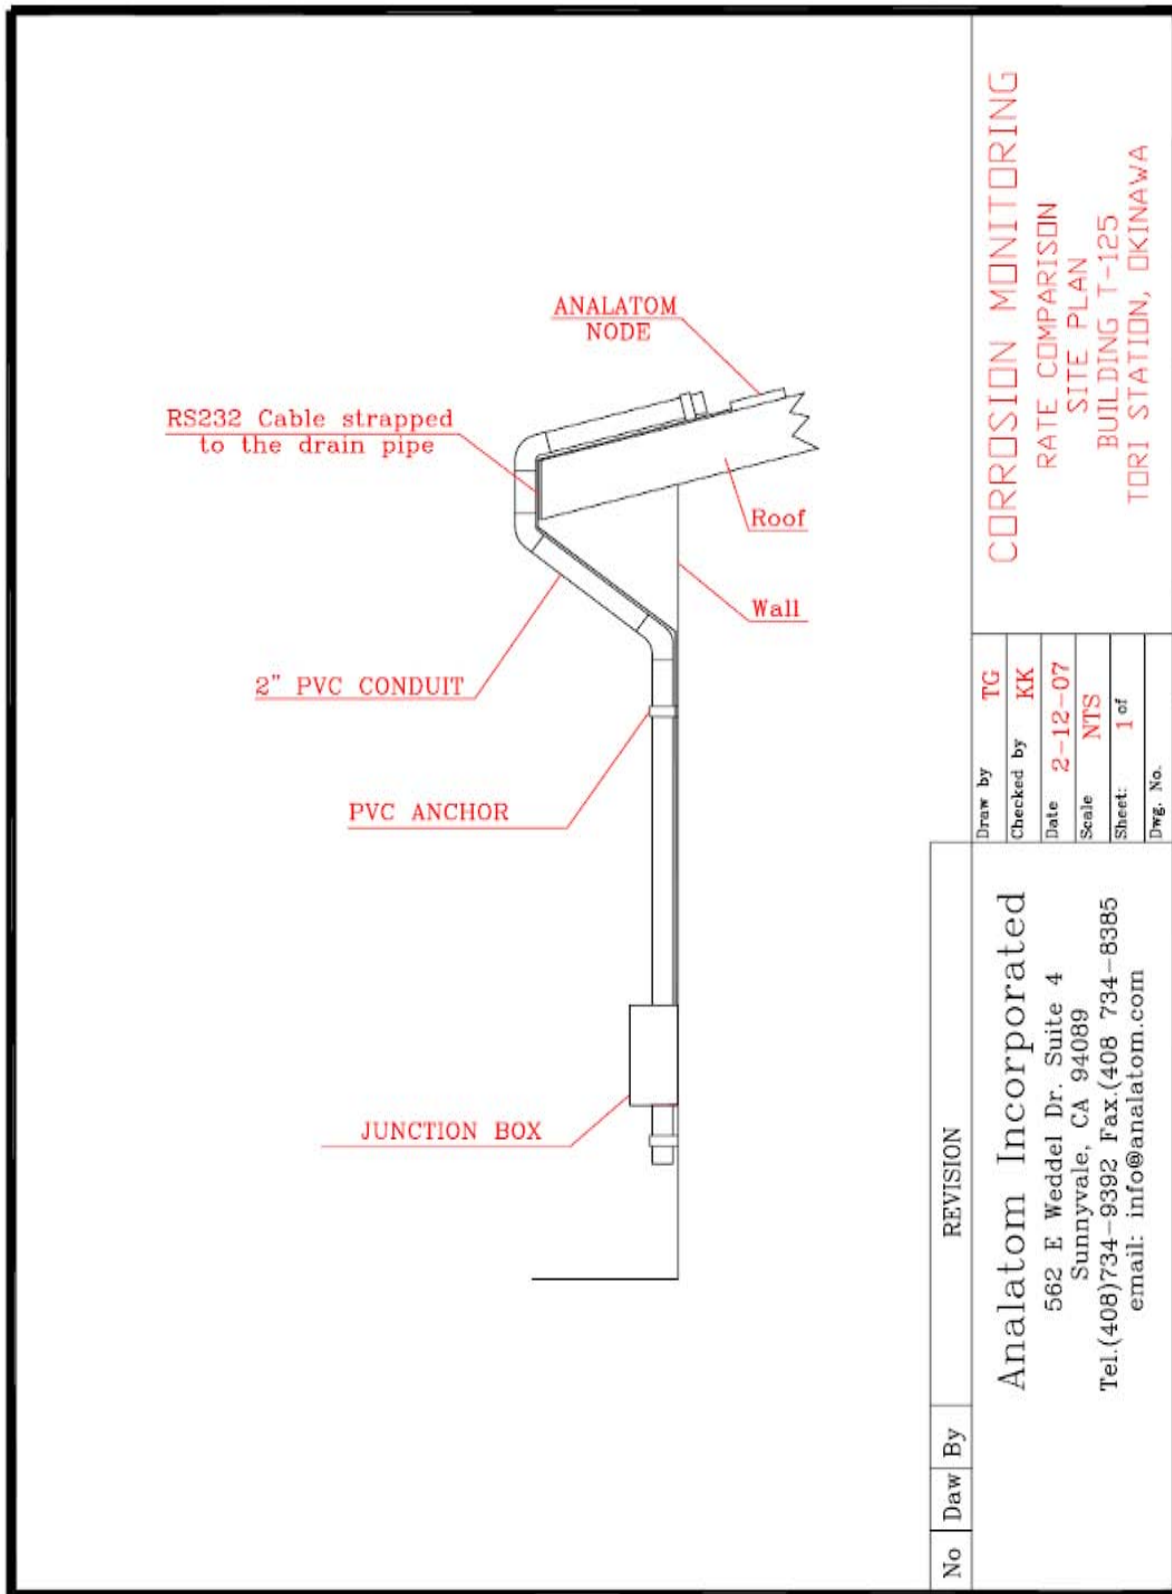
Figure 5: Cross Section of the Side Wall to Strap the RS232 Data Cable to the Drain Pipe

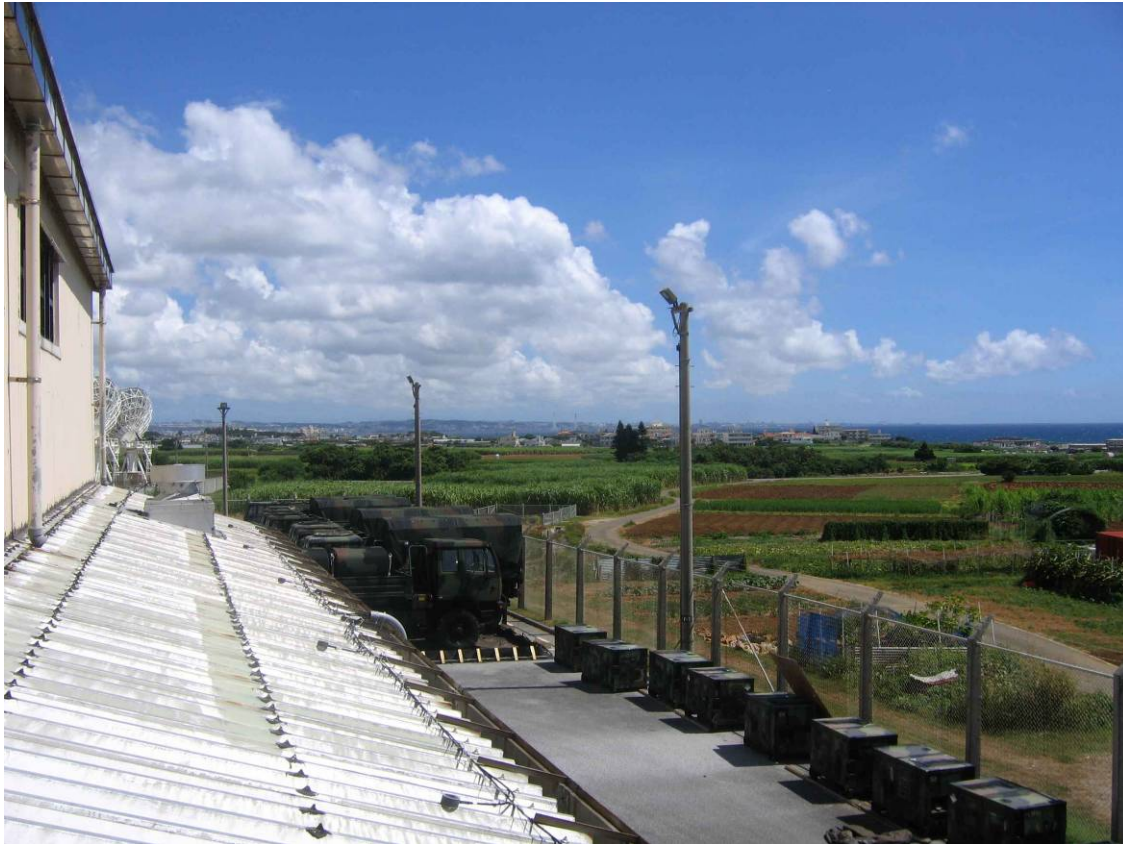
Figure 6: Roof of building where LPR corrosion sensors were installed.

A photo of the roof before installation of the sensors is shown in Figure 6.

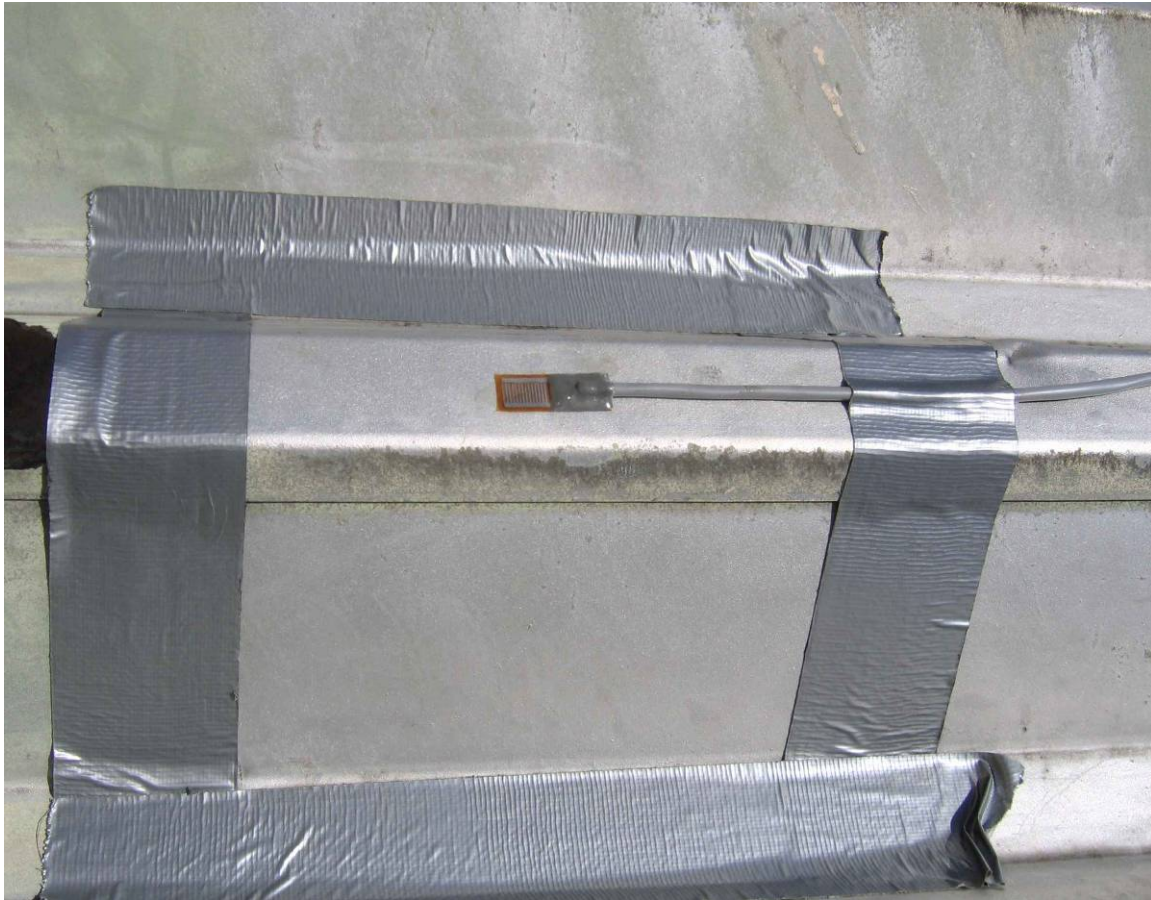
Figure 7: LPR corrosion sensor ready for coating.

ness suggested by the manufacturer. The primer adheres very well to metal, in addition to paint.

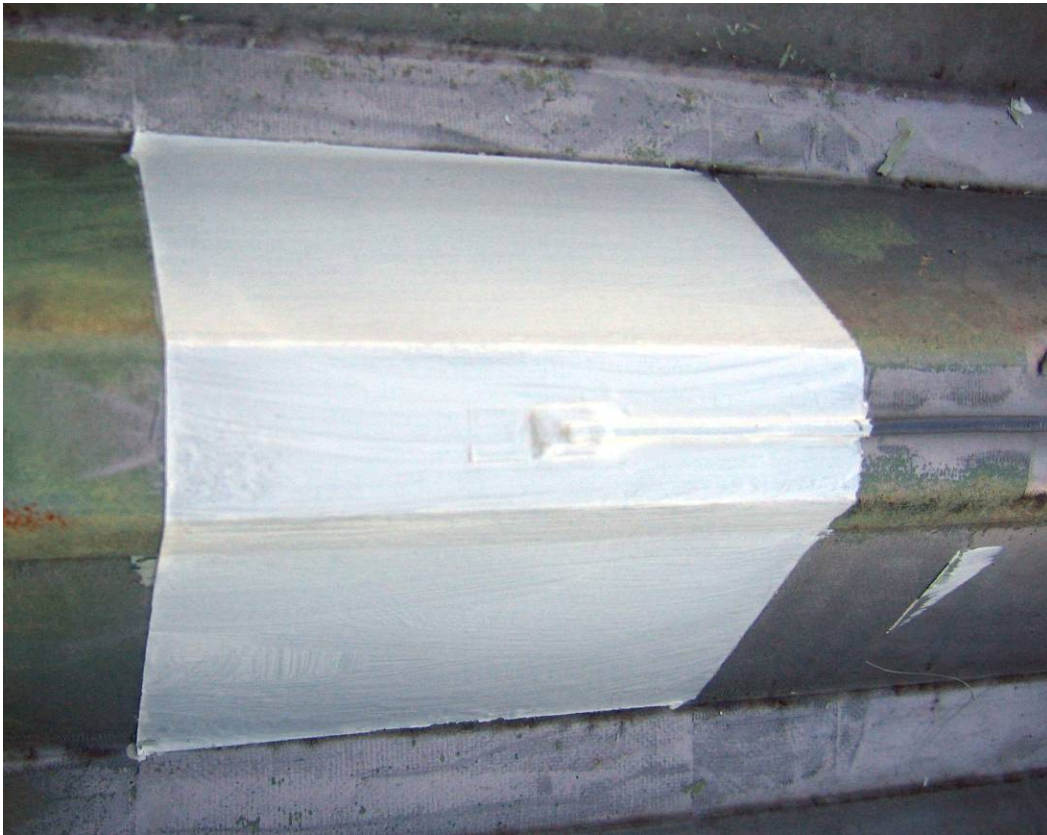
Figure 8: LPR Corrosion sensor after coating.

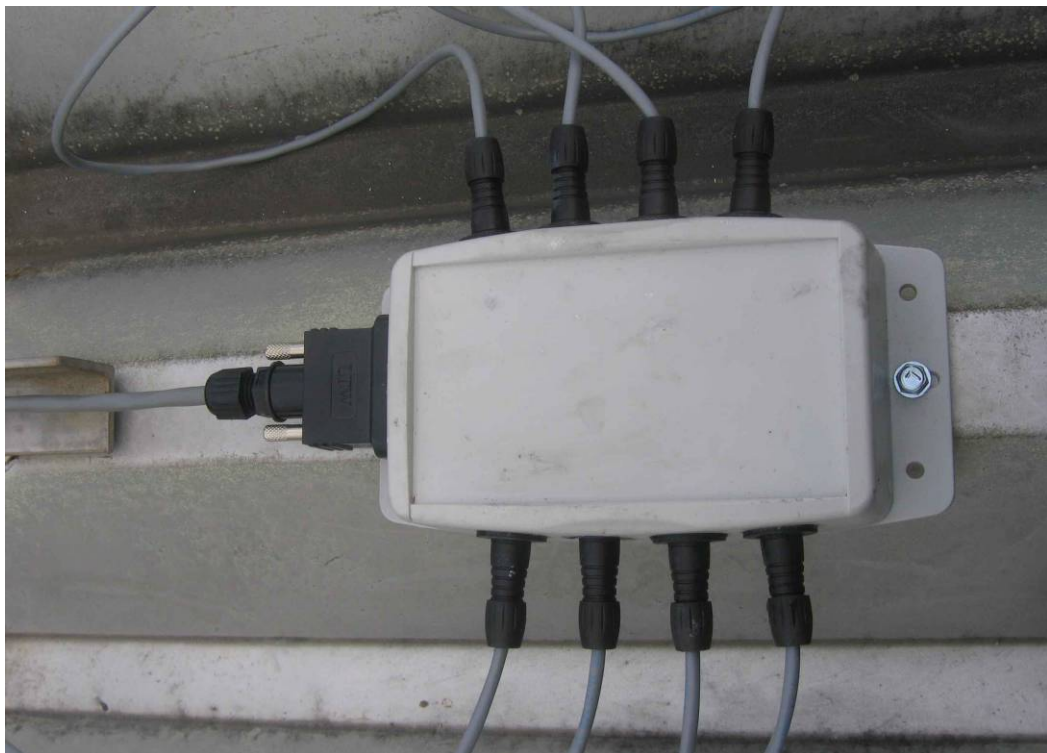
Figure 9: LPR corrosion sensor system data acquisition unit.

Next, the LPR corrosion sensor system node was installed onto the roof of the building, and all LPR corrosion sensor system cables attached to it, as shown in Figure 9. A long serial cable was also attached to the unit; this cable would eventually run down to a junction box on the side of the building, to allow personnel to communicate with the unit at ground level using a laptop computer.

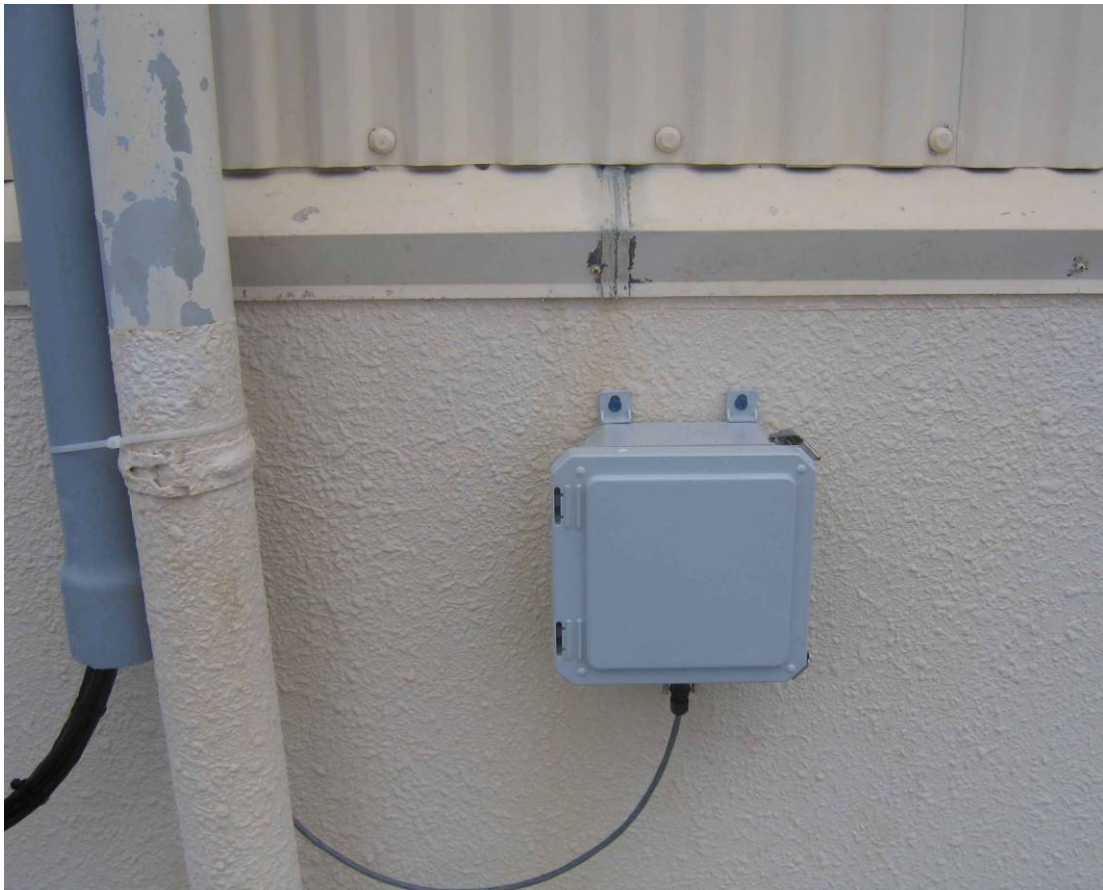
Figure 10: LPR corrosion sensor system serial interface box.

A junction box was then installed on the side of the building, as shown in Figure 10. The purpose of the junction box is to house the other end of the serial cable in a waterproof environment. This allows personnel the option of downloading data collected by the corrosion monitoring system on a periodic basis, if so desired.
